# Reaction-to-fire test report

Wall and ceiling lining tested in accordance with  
AS ISO 9705:2003 (R2016) and AS 5637.1:2015

Product: 12 mm thick Alpine FR MDF – Fire Retardant Panels

Job number: RTF200031

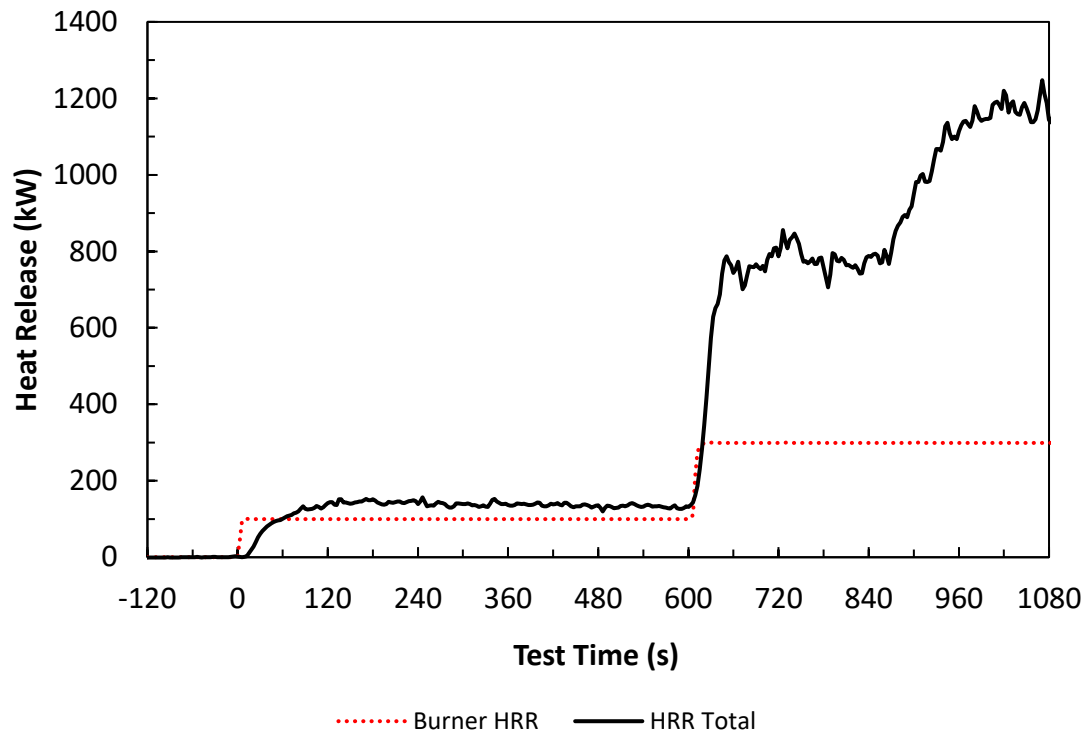
Figure 6 Heat release rate (HRR) of specimen and burner vs time

The material subjected to this AS ISO 9705:2003 (R2016) test achieved a heat release rate of 1 MW after 600 seconds of exposure to 100 kW followed by 324 seconds exposure to a 300 kW heat source. The maximum value of the 60 s running average was recorded to be 5.8 m<sup>2</sup>/s at 681 s.

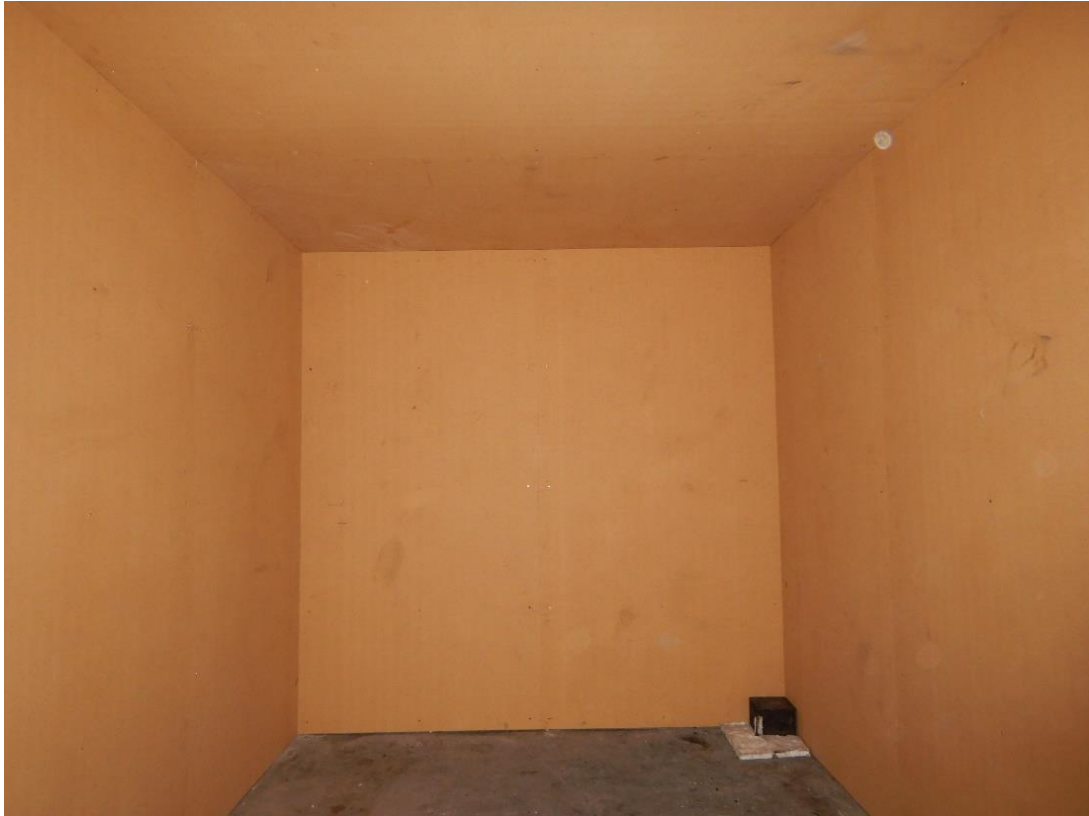
Figure 11 The system before the reaction-to-fire test.

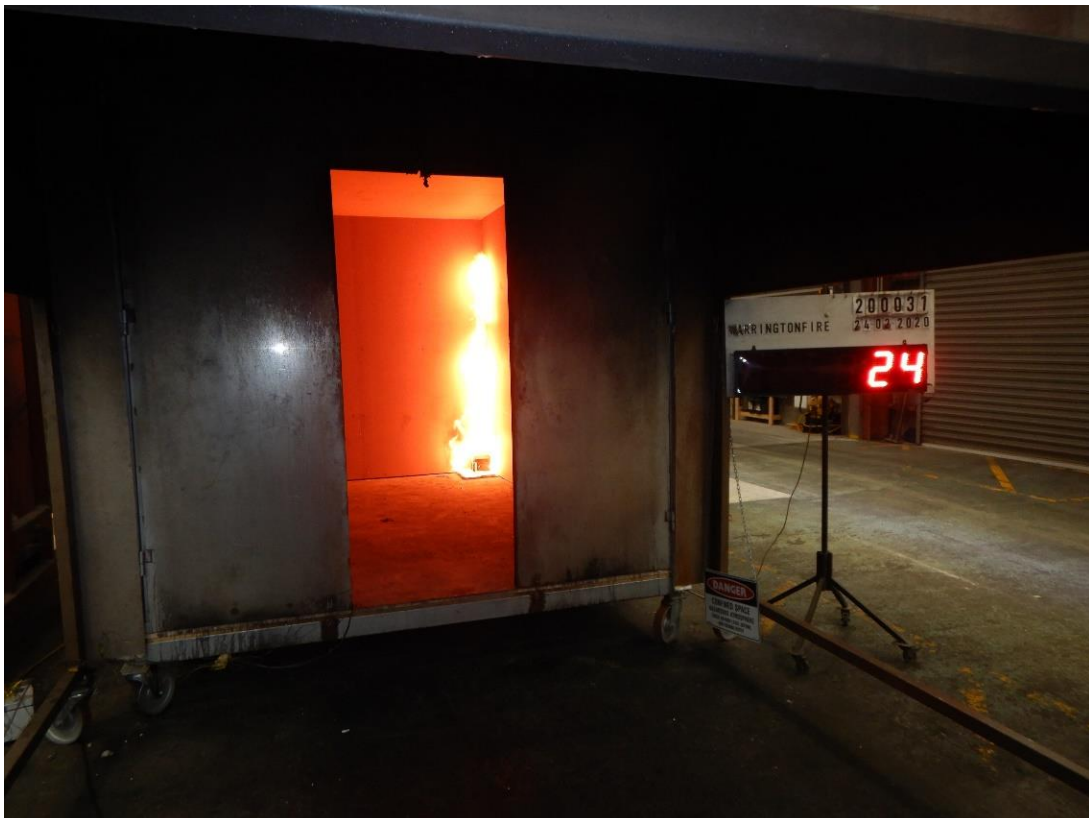
Figure 12 The system 24 seconds after burner ignition with the burner output of 100 kW.

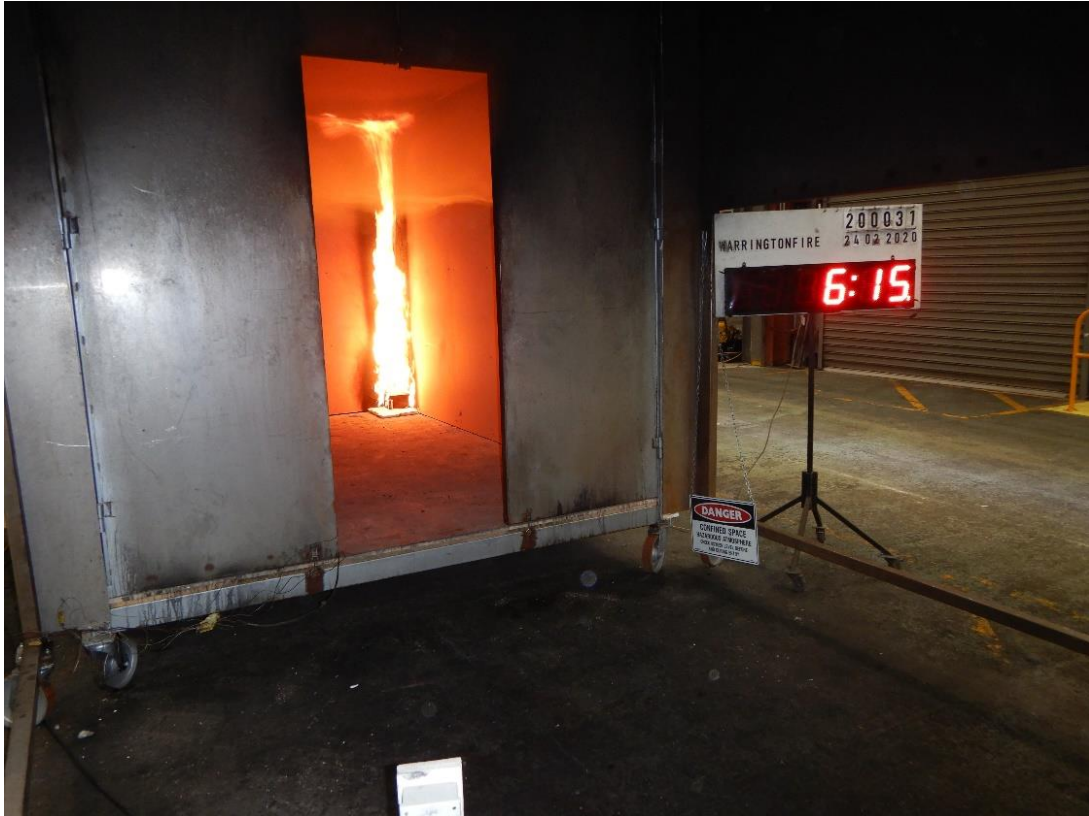
Figure 13 The system 06 minutes and 15 seconds after burner ignition with the burner output of 100 kW.

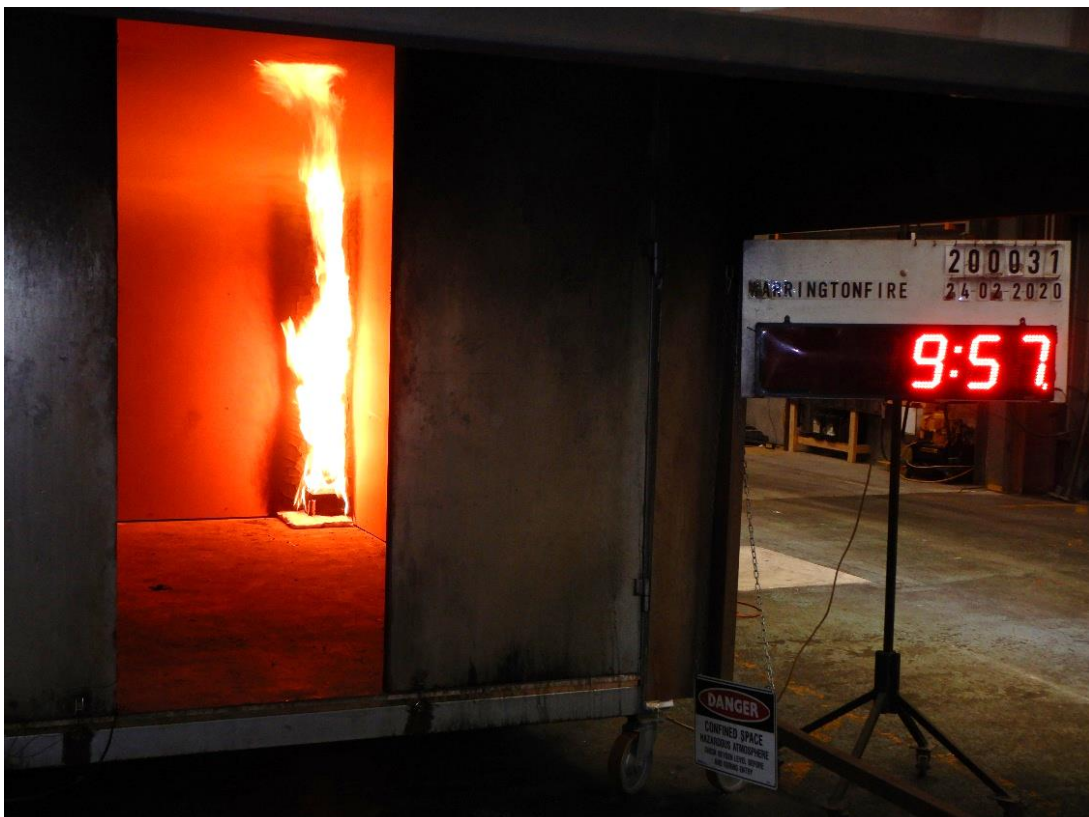
Figure 14 The system 09 minutes and 57 seconds after burner ignition with the burner output of 100 kW.

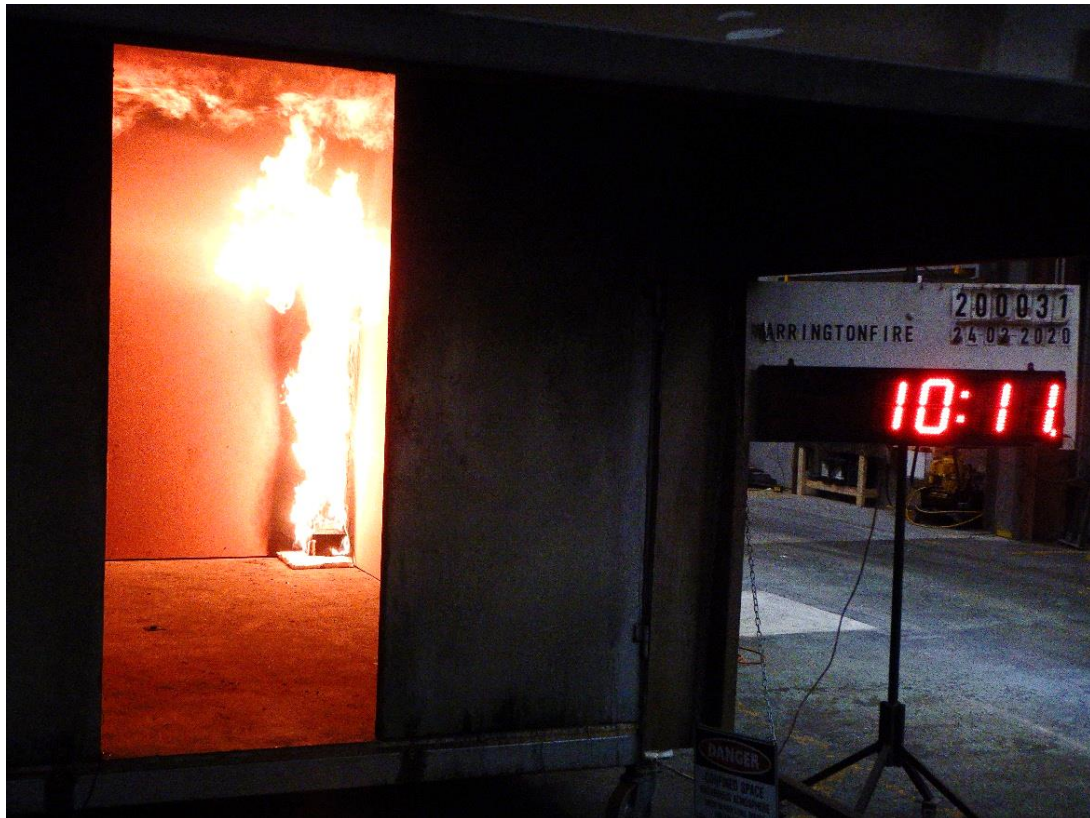
Figure 15 The system 11 seconds after the burner output was increased to 300 kW.

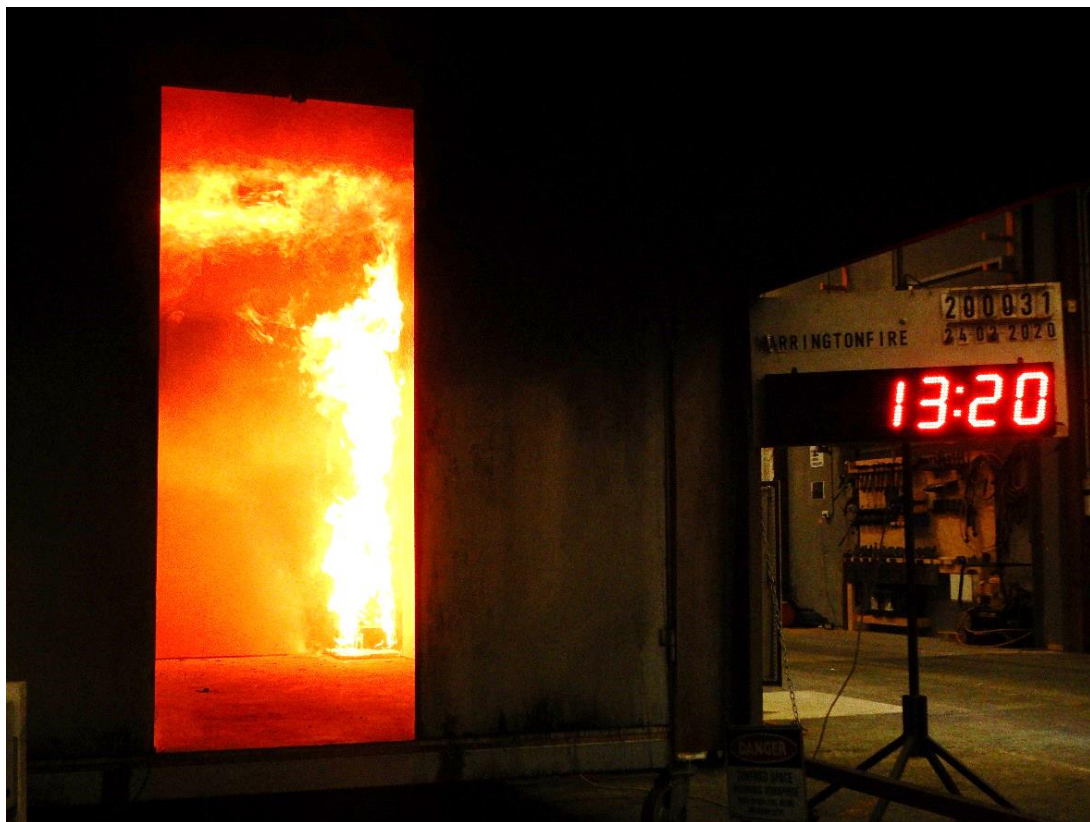
Figure 16 The system 03 minutes and 20 seconds after the burner output was increased to 300 kW.

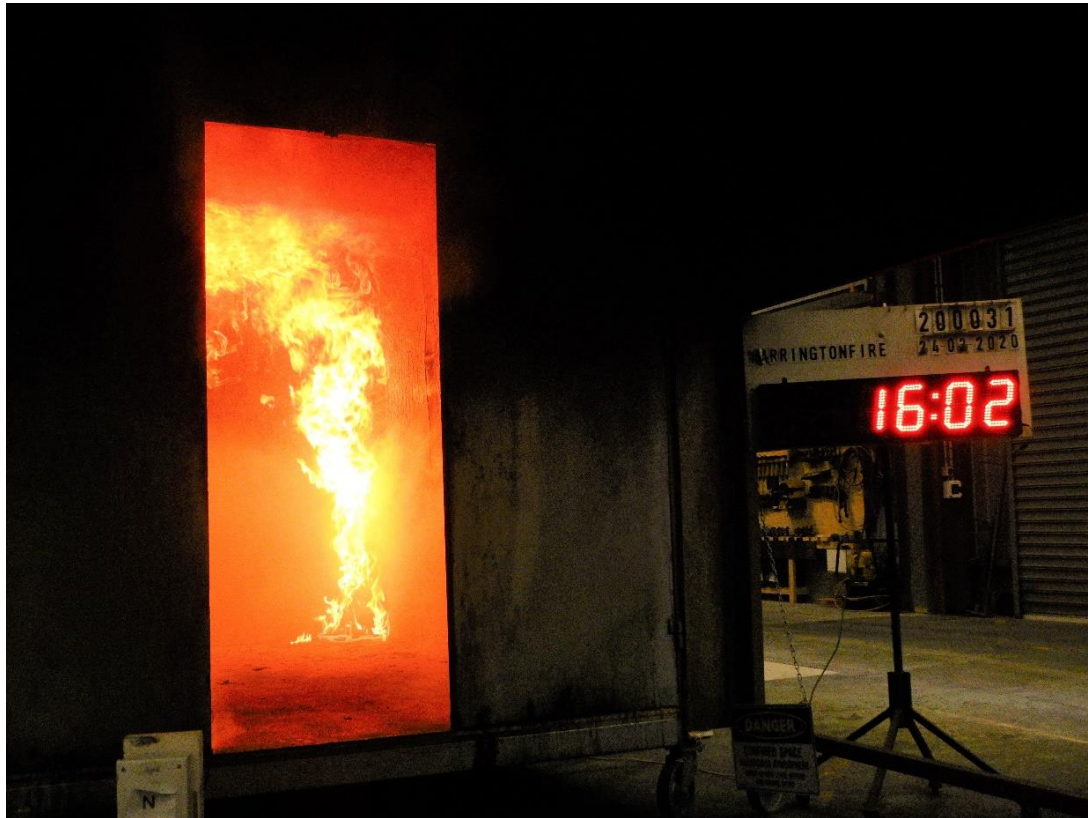
Figure 17 The system 06 minutes and 02 seconds after the burner output was increased to 300 kW.

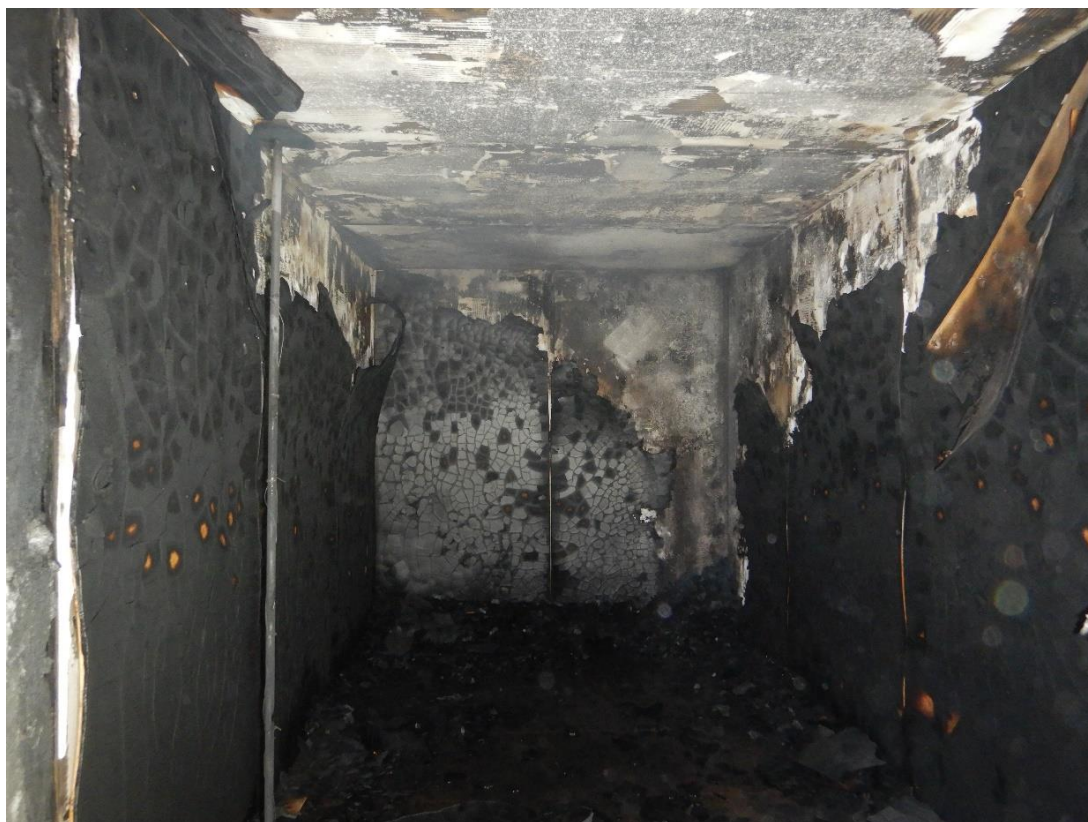
Figure 18 The system at the end of the reaction-to-fire test.
